TRANSPORTATION RESEARCH CENTER

ON-SITE AIR BAG INVESTIGATION

CASE NO. - 96-26
FLEET - PRIVATE VEHICLE
LOCATION ACCIDENT DATE - 1996

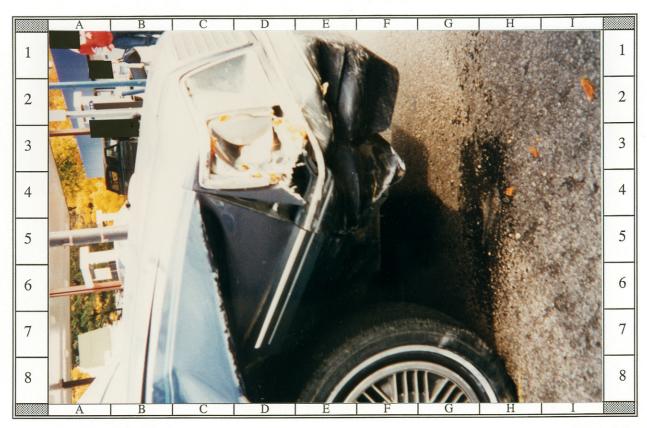
05: On-scene vertical close-up view, looking southeast, at Vehicle #2's direct front right damage area while at final rest

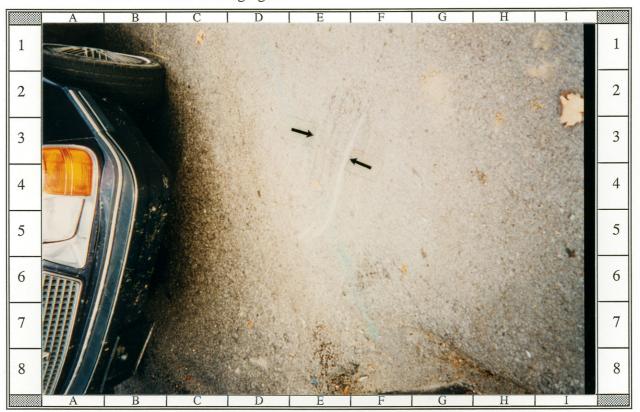
08: On-scene vertical view, looking north-northeast, of tire scuff from Vehicle #2's left front tire which occurred at maximum engagement with case vehicle

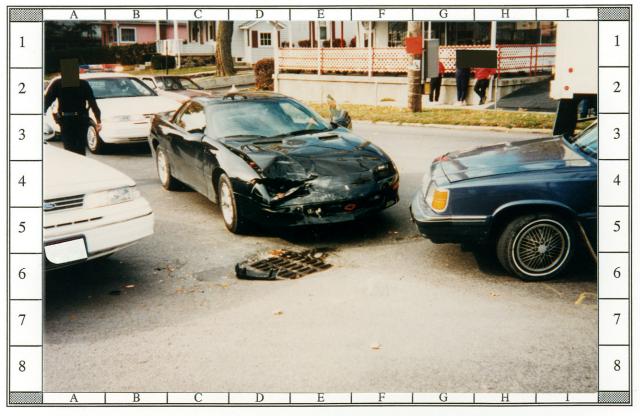
10: On-scene closer-up view, looking west-northwest, of Case Vehicle and Vehicle #2 at final rest near drainage grate showing Case Vehicle's front right damage

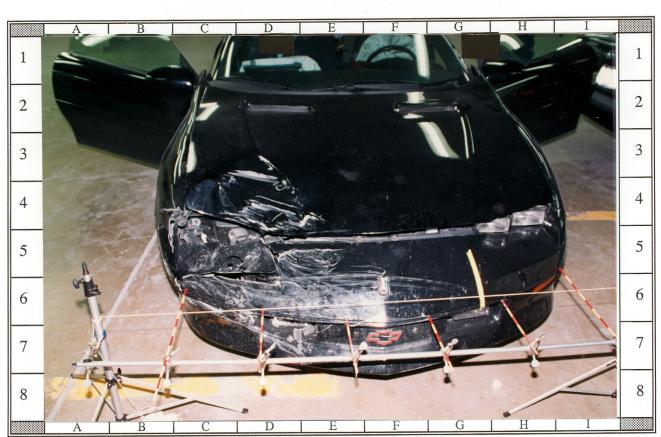
23: Case Vehicle's damaged front with contour gauge present; NOTE: direct damage extends from front right bumper corner to yellow tape

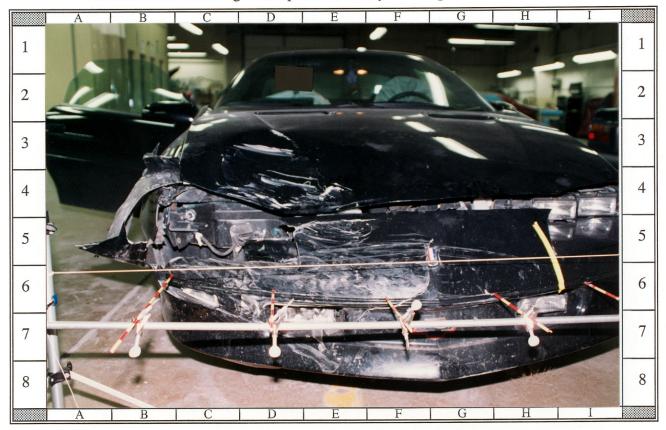
24: Close-up bumper level view of Case Vehicle's damaged front with contour gauge present; NOTE: direct damage extends from front right bumper corner to tape

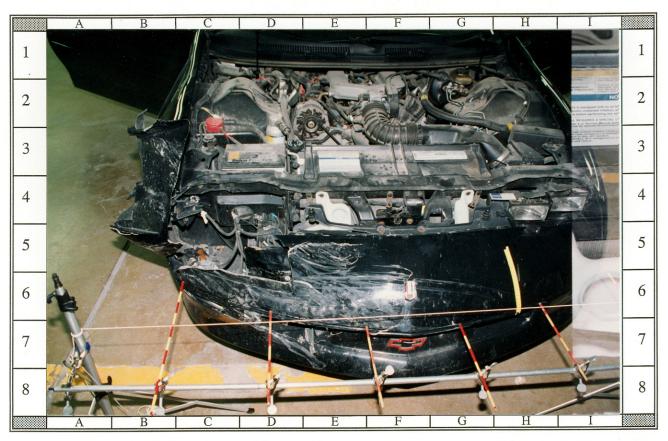
25: Case Vehicle's damaged front with contour gauge present and hood raised

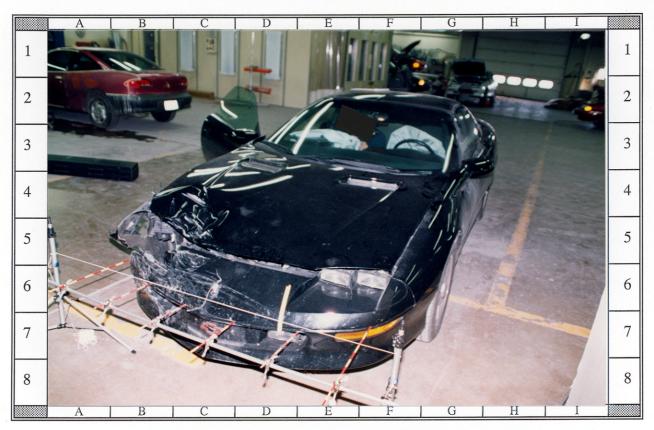
27: Case Vehicle's frontal damage viewed from approximately 15 degrees left of front

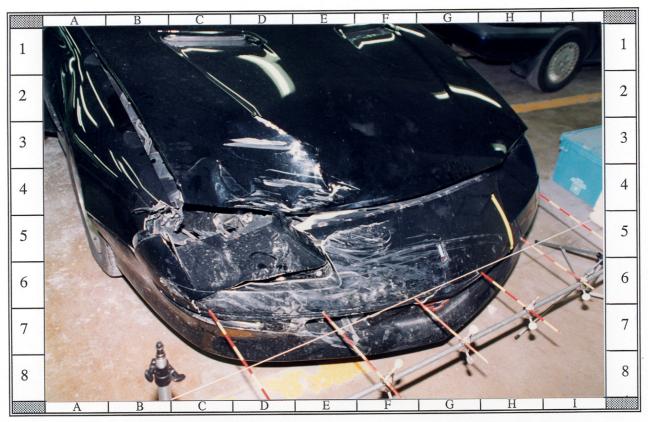
32: Case Vehicle's frontal damage showing direct damage which begins right of yellow tape, viewed from approximately 15 degrees right of front

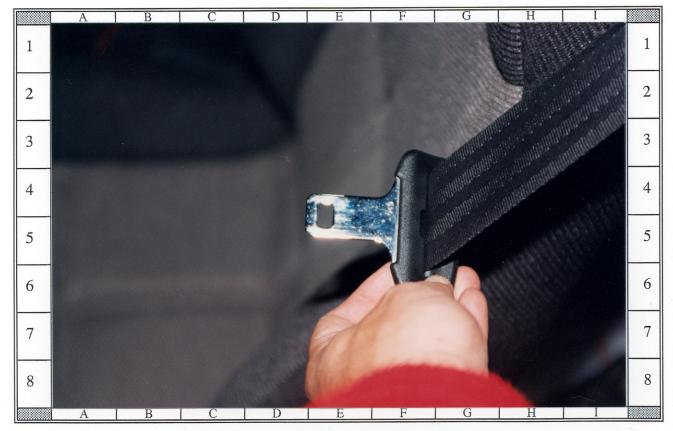
34: Case Vehicle's driver side seatbelt latch showing evidence of prior usage

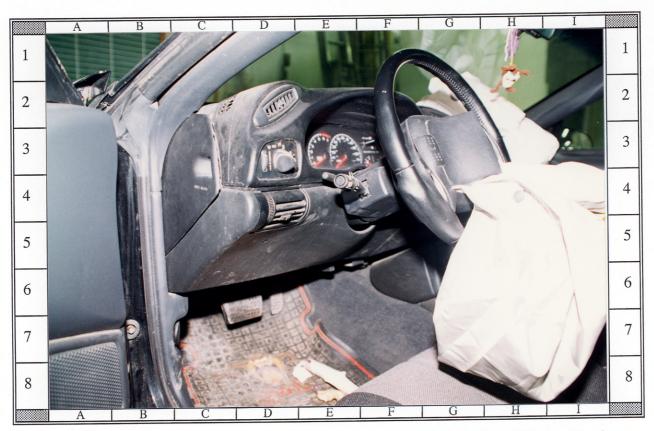
35: Case Vehicle's toe pan area, steering column, dash, and deployed driver side air bag viewed from left; NOTE: numerous marks to knee bolster

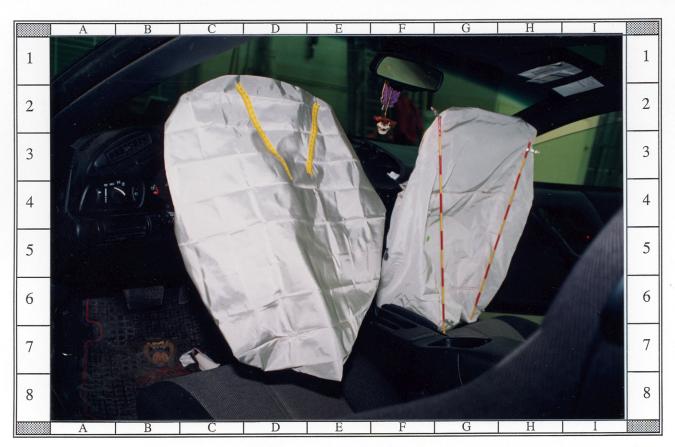
37: Case Vehicle's deployed driver and right front passenger side air bags; NOTE: "V"-shaped yellow tape indicates suspected area of contact on driver's air bag

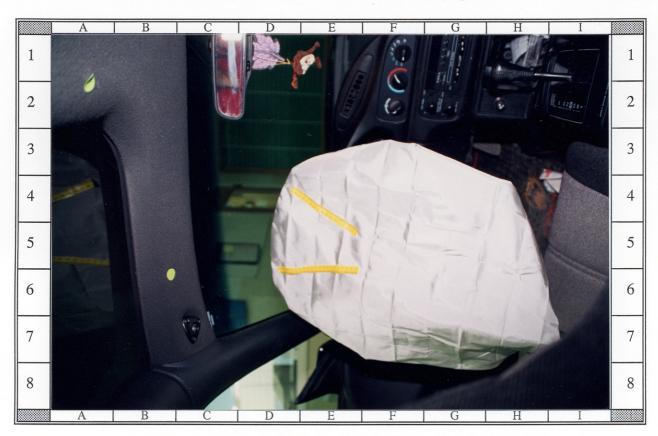
39: Vertical view of Case Vehicle's driver side seating area showing contact to roof (i.e., broken sunvisor); NOTE: "T"-roof with outboard glazing

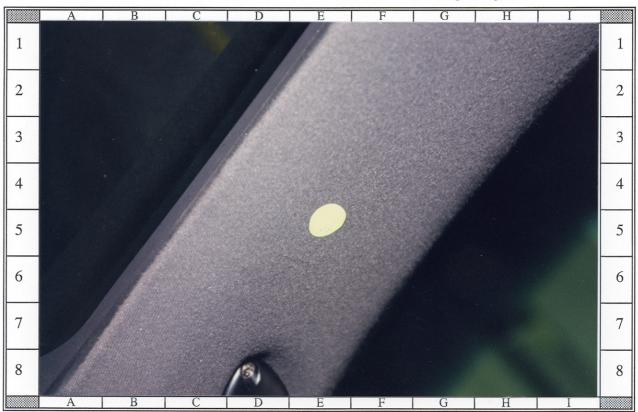
40: Close-up of contact mark on Case Vehicle's roof over driver's position near sunvisor's anchor; NOTE: sunvisor broken off

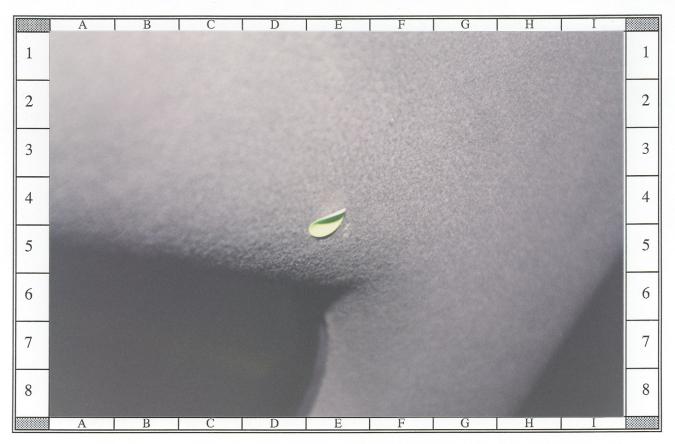
41: Vertical close-up of suspected mucous on Case Vehicle's roof near driver's side roof glazing and above left edge of rearview mirror

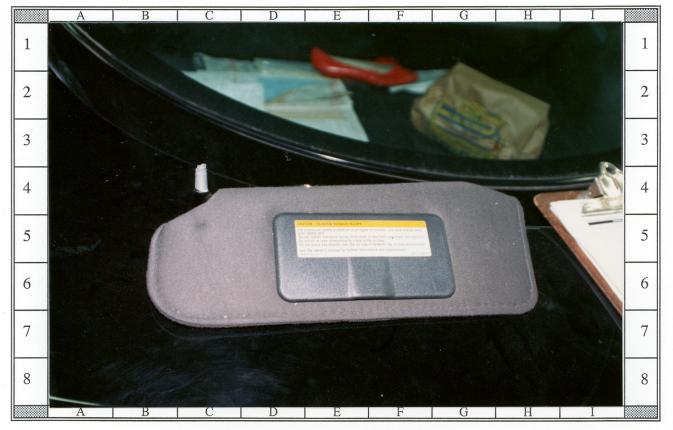
42: Underneath side of Case Vehicle's broken off driver side sunvisor; NOTE: sunvisor laid on hatchback

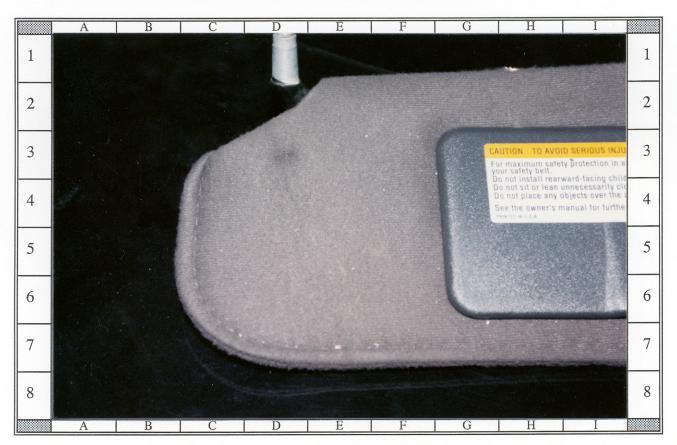
43: Close-up of underneath side of Case Vehicle's broken off driver side sunvisor showing contact mark (D-3); NOTE: sunvisor was down at time of impact

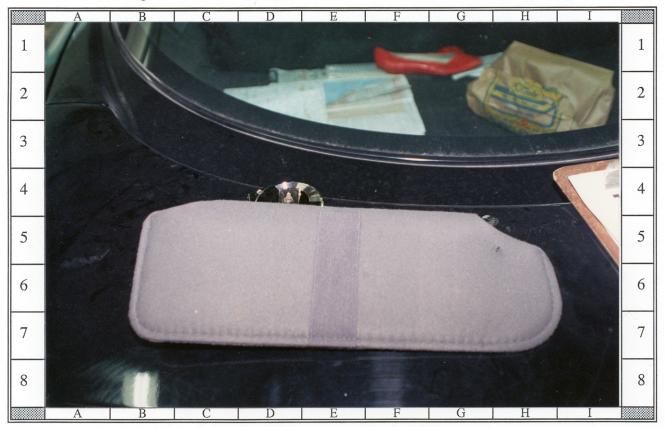
44: Front side of Case Vehicle's broken off driver side sunvisor; NOTE: sunvisor laid on hatchback and elastic storage band on front

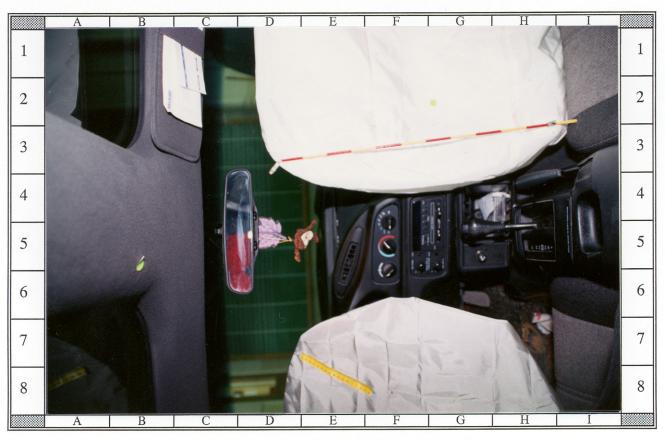
45: Vertical view of Case Vehicle's center console and dash, "T"-roof, and deployed front air bags; NOTE: automatic transmission selector lever and contact on roof

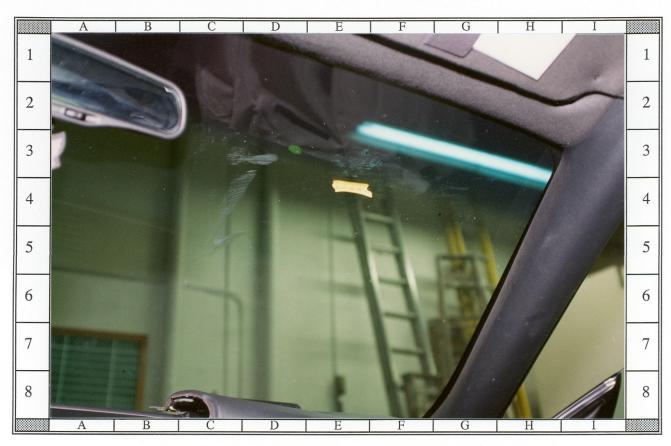
This contractor initially considered the windshield as a possible source of contact for the child's head; see SELECTED PHOTOGRAPH #47. However, this source was ruled out because of the occupant's initial pre-crash posture (i.e., leaning to the left with her head turned toward to left) and the fact that her medical records found no trauma to her neck/cervical spine (i.e., her history and physical exam indicated that her C-spine was supple without any tenderness, crepitus, or deformity upon palpation and range of motion testing and a cervical x-ray was unremarkable).

47: Close-up of two marks on Case Vehicle's right windshield; NOTE: one on left is from cover flap the other's source is unknown

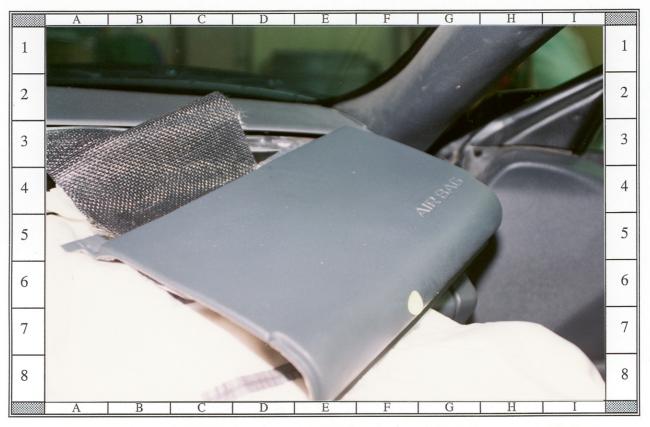
49: Front center close-up view of Case Vehicle's passenger side air bag module's cover flap showing grease smudge; NOTE: tether connected to cover flap

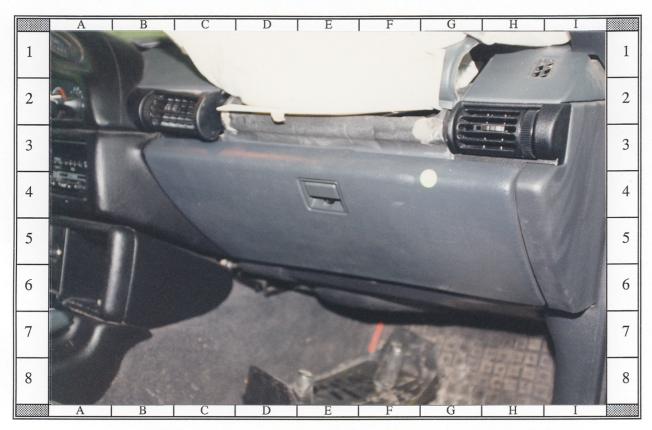
51: Case Vehicle's glove box door showing scuff (i.e., on left side of dot) toward right side of glove box

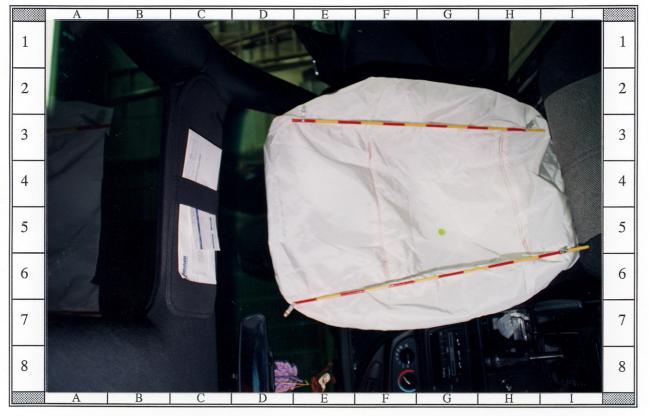
52: Vertical view of Case Vehicle's deployed right front air bag viewed from center rear area; NOTE: contact evidence near dot, "T"-roof glazing, and sunvisor

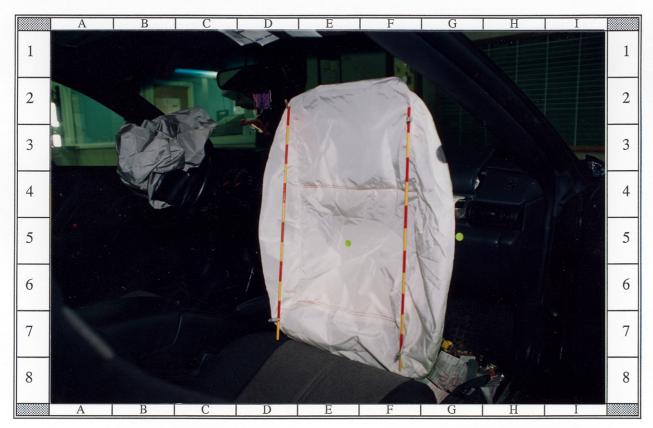
An inspection of the right front passenger's air bag revealed contact evidence (i.e., blood and oil smears) to the center left portion; see SELECTED PHOTOGRAPHS #52 through #54. In addition, there appeared to be an oil smudge on the leading edge of this right front passenger side air bag module's cover flap; see SELECTED PHOTOGRAPHS #46, #48, and #49. However, it should be noted that on previous Special Crash Investigation cases, when the cover flap was directly contacted, there was usually skin evidence found on the top portion of the air bag. There was no skin evidence observed in this crash.

53: Case Vehicle's deployed right front air bag viewed from outside right front door; NOTE: evidence of contact near dot on air bag and glovebox

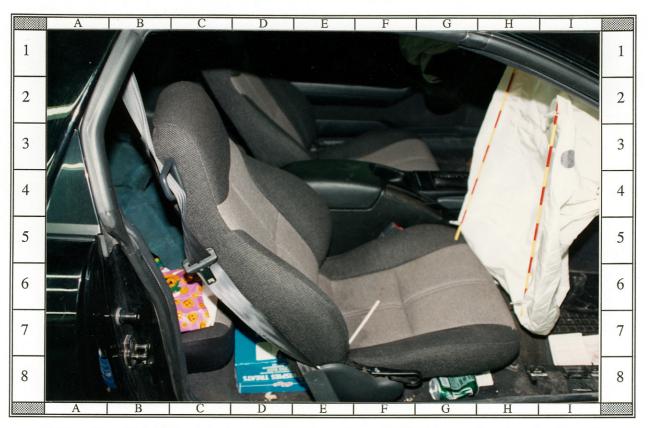
55: Case Vehicle's right front passenger seating area showing reclined seatback position and seatbelt; NOTE: blood spot on seat cushion near straw

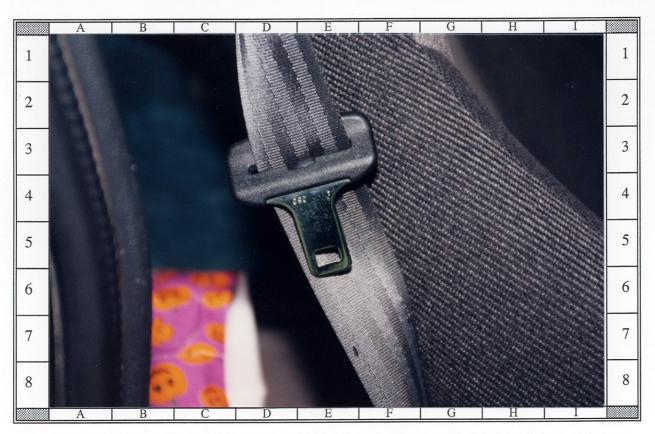
57: Close-up of front side of Case Vehicle's right front seatbelt latch plate showing no signs of usage during crash and very little sign of previous usage

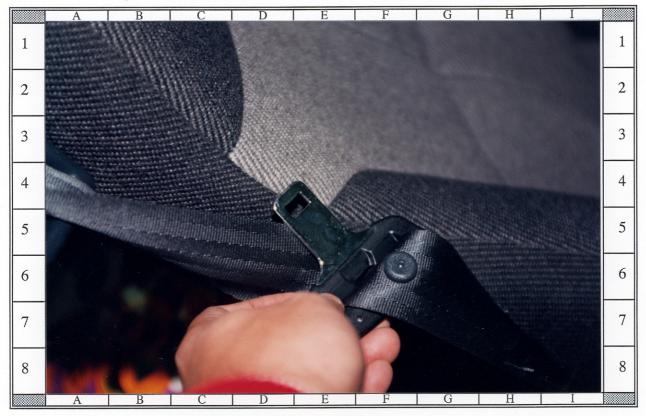
58: Close-up of backside of Case Vehicle's right front seatbelt latch plate showing no signs of usage during crash

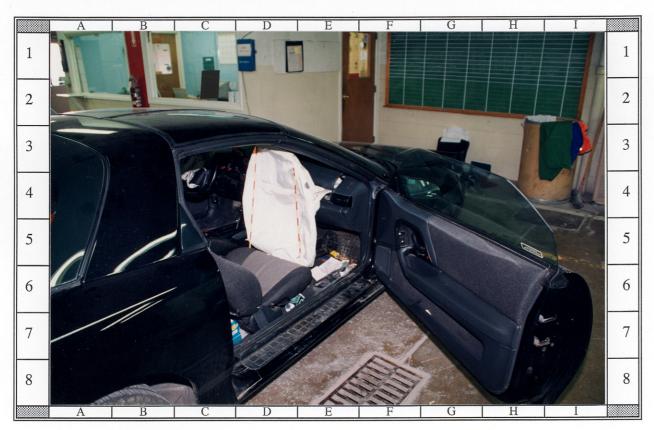
59: Interior surface of Case Vehicle's right front door, passenger's seating area, and deployed air bag viewed from outside; NOTE: no contact evidence on door panel

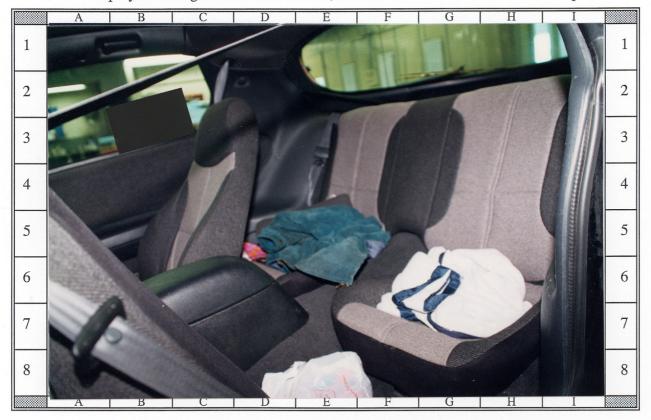
60: Case Vehicle's rear seat showing two seating positions equipped with three-point safety belts and neither rear windows nor head restraints

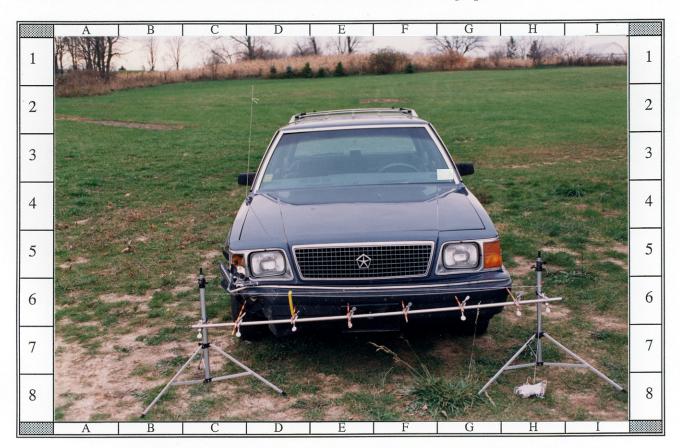
61: Vehicle #2's frontal damage with contour gauge present at bumper level

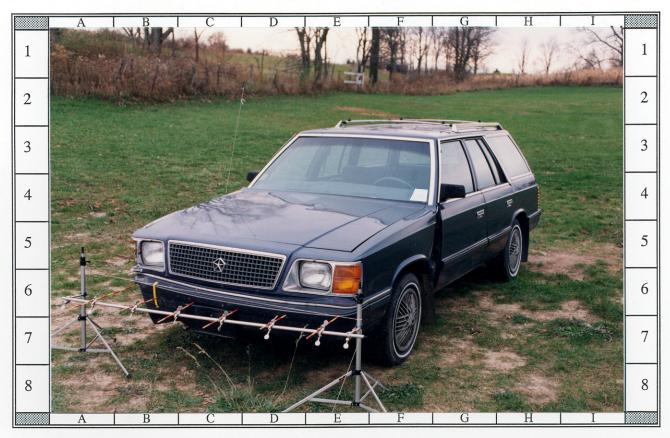
62: Vehicle #2's frontal damage with contour gauge present, viewed from approximately 30 degrees left of front; NOTE: induced damage to left fender

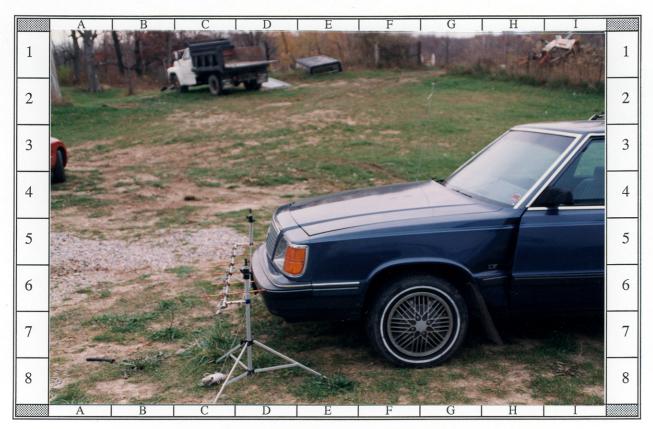
63: Reference line view of vehicle #2's frontal damage, viewed from left, with contour gauge present at bumper level

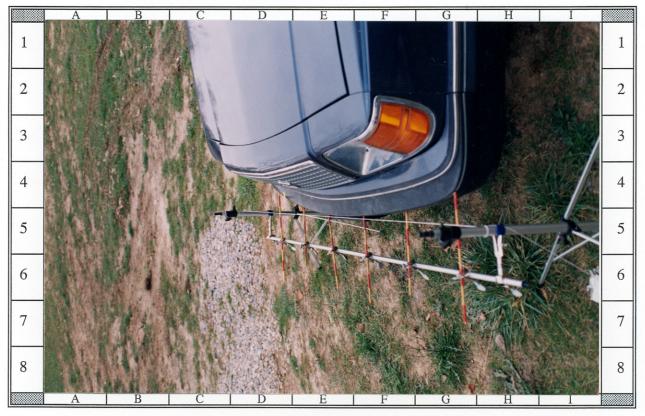
64: Vertical close-up view of reference line of Vehicle #2's frontal damage, viewed from left, with contour gauge present at bumper level

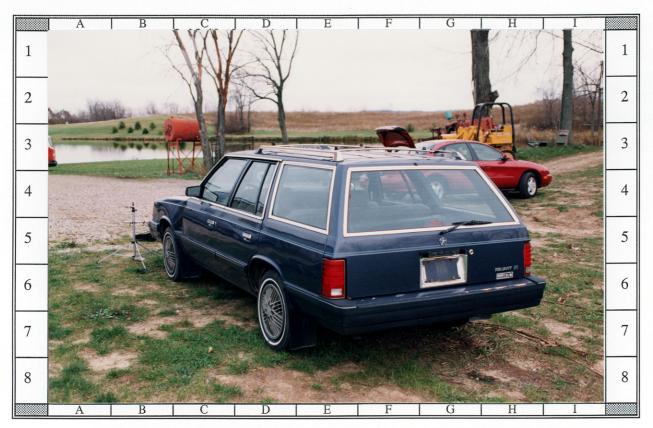
65: Vehicle #2's undamaged left side (except fender) and back, viewed from approximately 30 degrees left of back

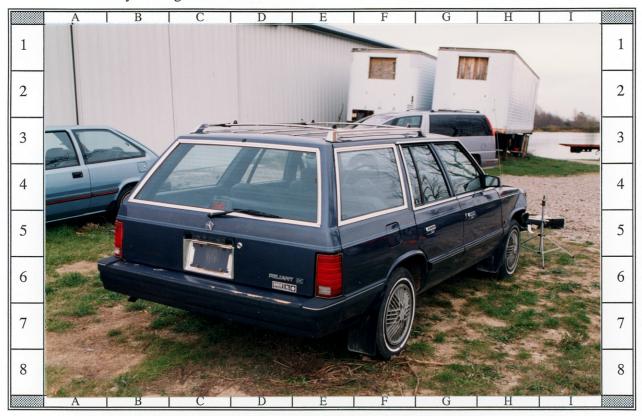
66: Vehicle #2's undamaged right side (except fender) and back, viewed from approximately 30 degrees right of back

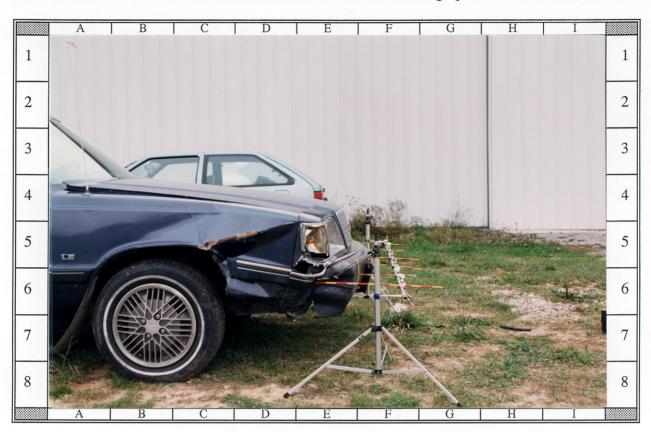
67: Reference line view of Vehicle #2's deformed front, viewed from right, with contour gauge present at bumper level

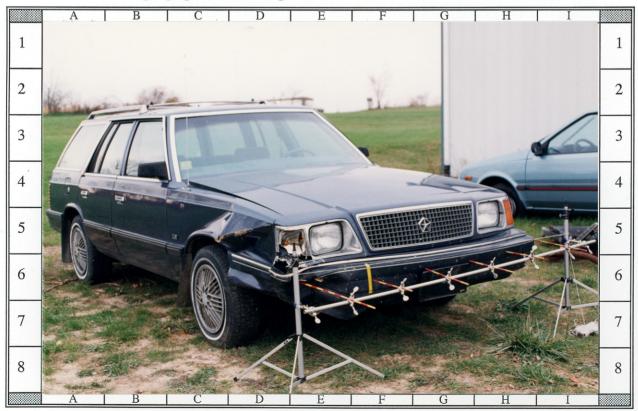
68: Vehicle #2's frontal damage with contour gauge present, viewed from approximately 30 degrees right of front; NOTE: direct damage to right fender

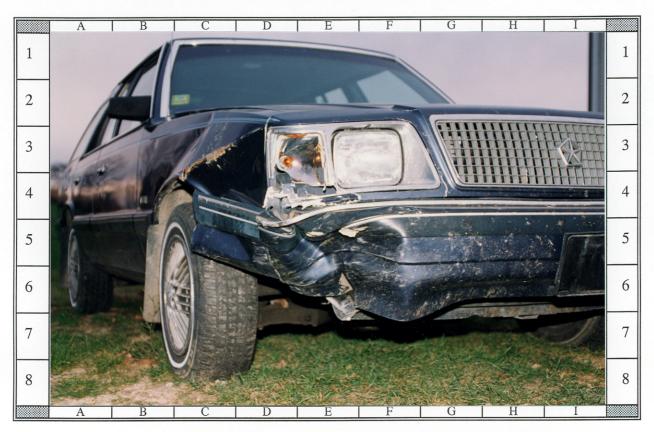
69: Close-up view of Vehicle #2's front right corner damage viewed from approximately 15 degrees right of front

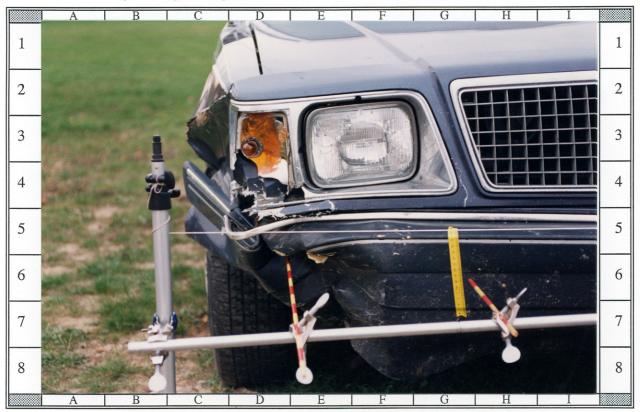
70: Close-up of direct damage to Vehicle #2's front right corner viewed from front; NOTE: direct damage extends from yellow tape rightward to corner

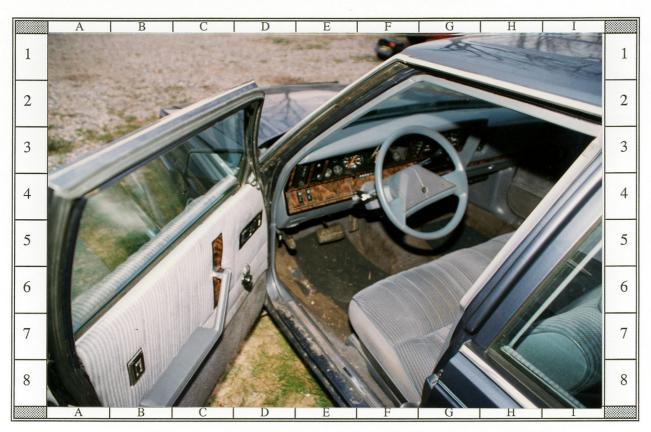
71: Interior surface of Vehicle #2's driver side door and driver's seating area viewed from outside; NOTE: no contact evidence on door panel

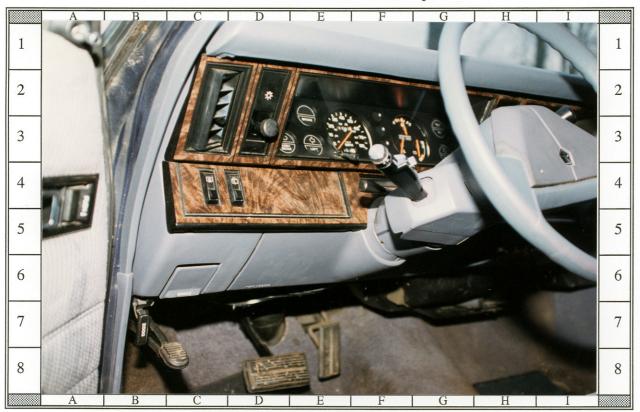
72: Vehicle #2's steering column, toe pan, lower dash, and instrument panel showing no evidence of contact

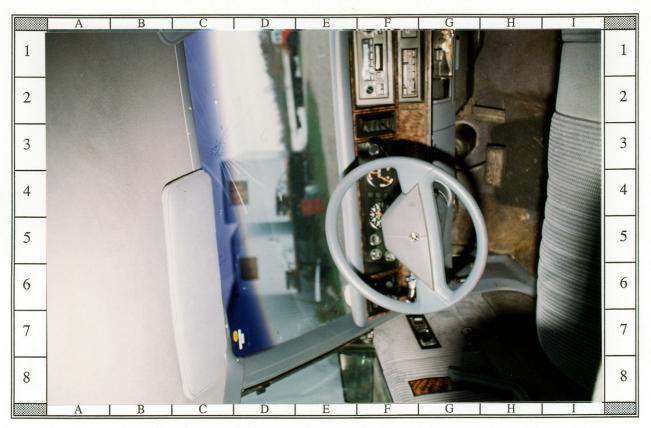
73: Vertical view of Vehicle #2's driver seating area and greenhouse showing cracked windshield, broken off rearview mirror, and no contacts to rim or sunvisor

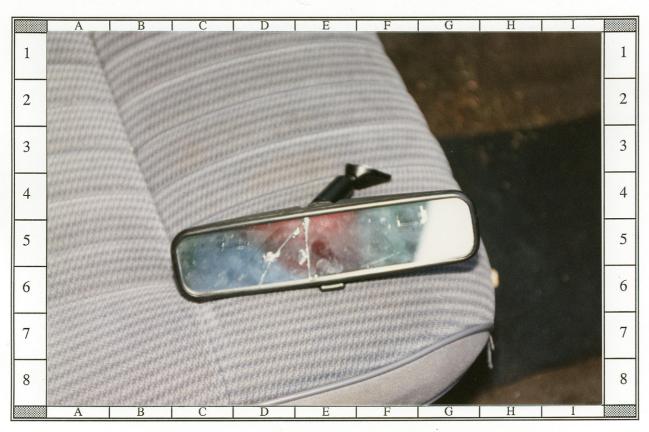
#75: Close-up of Vehicle #2's broken off, contacted, and cracked rearview mirror

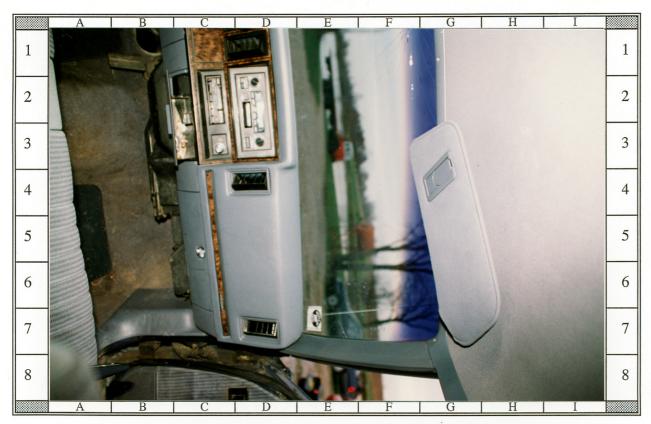
76: Vertical view of Vehicle #2's right front passenger seating area and greenhouse showing no visible evidence of contact

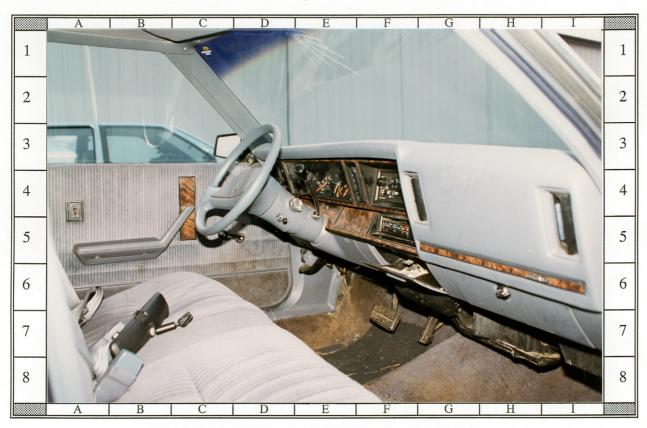
77: Vehicle #2's front seating area, greenhouse, steering wheel, and dash, viewed from right; NOTE: three front seating positions and no clutch pedal

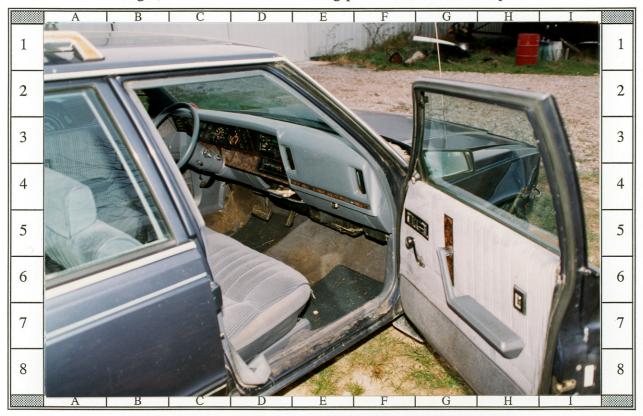
78: Interior surface of Vehicle #2's right front door and passenger's seating area viewed from outside; NOTE: no contact evidence on door panel

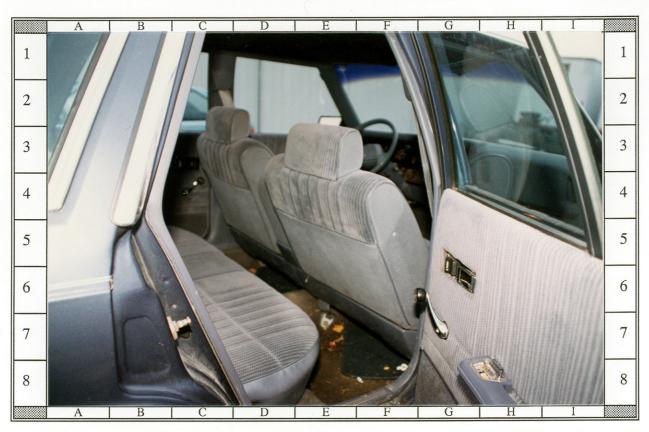
79: Interior surface of Vehicle #2's right rear door and seating area viewed from outside; NOTE: no contact evidence on door panel or front seat backs

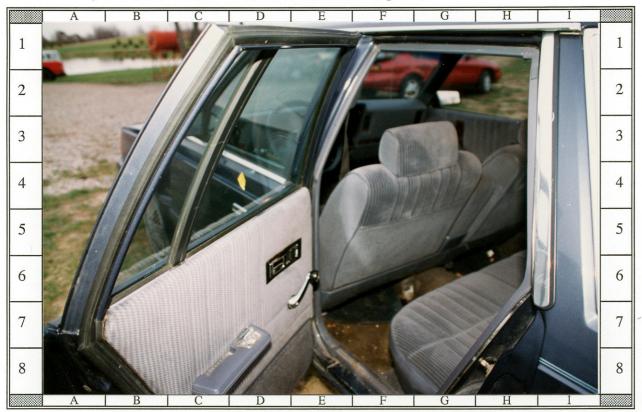
80: Interior surface of Vehicle #2's left rear door and seating area viewed from outside; NOTE: contact evidence to left window (i.e., tape)

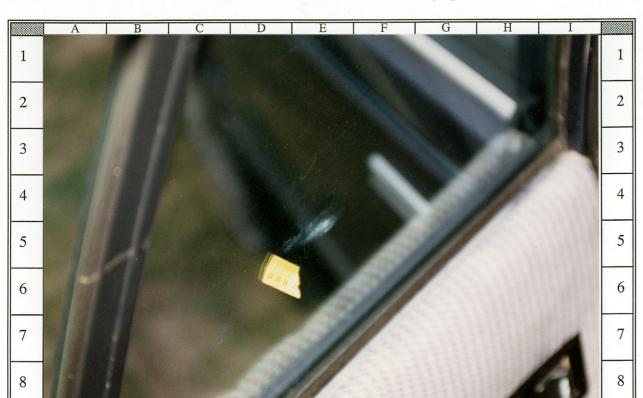
#81: Close-up of make-up smear on Vehicle #2's left rear door glazing

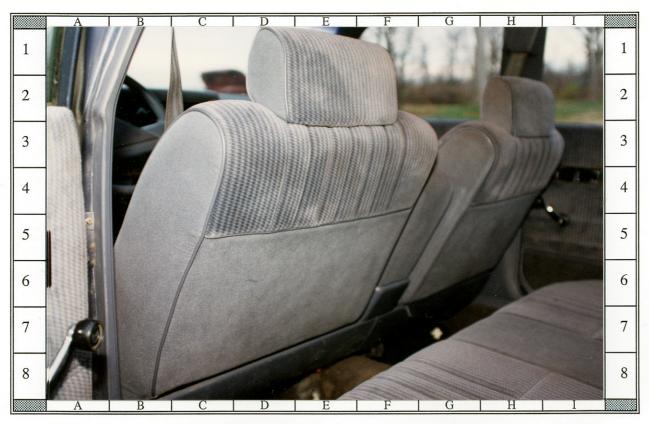
82: Close-up of Vehicle #2's front seat backs showing no evidence of contact; NOTE: adjustable front seat head restraints and outboard three-point safety belts
